Sylvan Lake Aquatic Vegetation Management Plan Revision 2007 Noble County, Indiana

December 6, 2007

SYLVAN LAKE AQUATIC PLANT MANAGMEENT PLAN REVISION NOBLE COUNTY, INDIANA

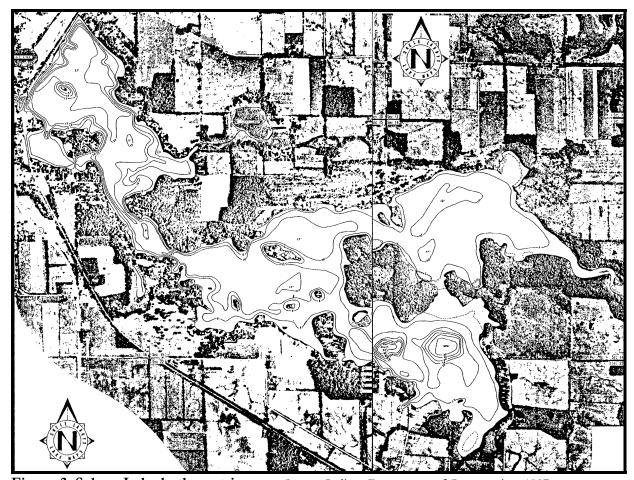
Figure 3. Sylvan Lake bathymetric map. Source: Indiana Department of Conservation, 1927.

Figure 3 presents Sylvan Lake's morphology. The lake consists of three deep basins surrounded by shallower water. The lake's deepest point lies in the southeast basin of the 669-acre lake. Here, the lake extends to its maximum depth of 33 feet (10 m; Table 2). One shallower hole lies east of the deepest hole in the lake reaching a maximum depth of 30 feet (9.1 m).

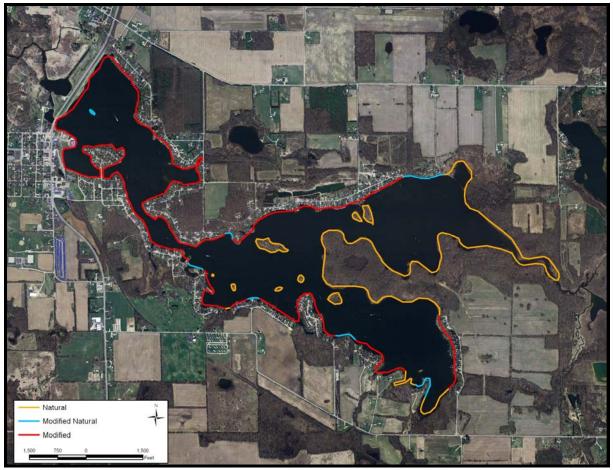
Figure 4. Shoreline surface type observed at Sylvan Lake, July 26, 2007.

Given the number of houses along Sylvan Lake's shoreline, it is not surprising that nearly 59% of Sylvan Lake's shoreline has been altered in some form. Along much of Sylvan Lake's shoreline (41%; 29,054 feet), trees and emergent vegetation have remained untouched; however, these areas are still affected by wave action and boat traffic (Figure 4). These areas are mapped as natural shoreline because they possess a large portion of all three aquatic vegetation strata (submerged, emergent, and floating). Other portions of the shoreline that are also mapped as natural include the islands in the lake that have been modified very little or not at all.

Approximately 53% of Sylvan Lake's shoreline has been largely altered from its natural state (Figure 4). Along these portions of Sylvan Lake's shoreline, emergent and floating rooted vegetation has been completely removed from adjacent to the shoreline. A majority of this shoreline has been converted to concrete or stone seawall. Natural shoreline remains along approximately 41% of Sylvan Lake's shoreline. Most of the natural shoreline areas include emergent, floating rooted vegetation, and wetland areas that have not been impacted by development yet.

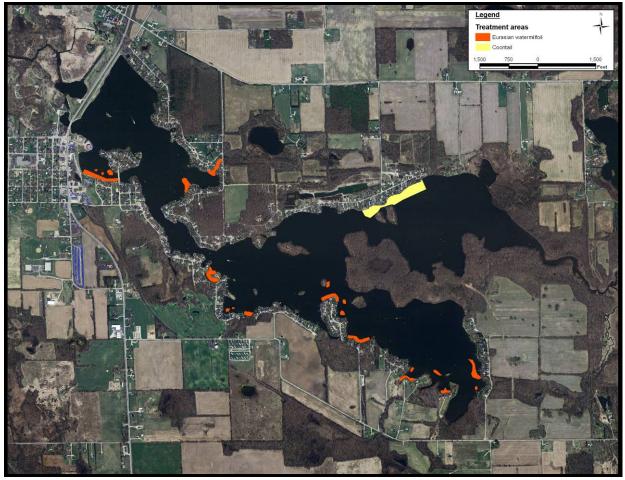
Figure 10. Eurasian watermilfoil and coontail treatment areas located on Sylvan Lake. Weed Patrol completed treatment for Eurasian watermilfoil on June 25, 2007 and treated for coontail on August 6, 2007.

On May 8, 2007, Weed Patrol treated 265 acres of curly-leaf pondweed. Additionally, on June 25, 2007, Weed Patrol treated a total of 18.5 acres of Eurasian watermilfoil. Both treatments occurred during sunny conditions (approximately 70°F) with a light wind. A third treatment occurred on August 6, 2007 for coontail (approximately 7.5 acres). Figures 10 and 11 indicate the specific locations, plant species targeted, and size of area targeted during the aforementioned herbicide application. For selective Eurasian watermilfoil control, roughly 2 ppm of 2,4-D herbicide (approximately 1 gallon per acre depending on the depth and size of the area) was applied. Often an herbicide can be applied at a lighter rate when treating big areas. For curly-leaf pondweed control, 0.5 mg/L of Aquathol K herbicide was used (applied at a rate of approximately 1 gallon per acre). This low rate was used to control curly-leaf pondweed, which is more sensitive to Aquathol, while not killing native pondweeds. For both treatments, herbicide was applied by making narrow passes through the treatment area. Coontail was treated with Reward at a rate of 1.5 gal/acre. No additional treatment occurred on Sylvan Lake that was not funded through the IDNR LARE program.

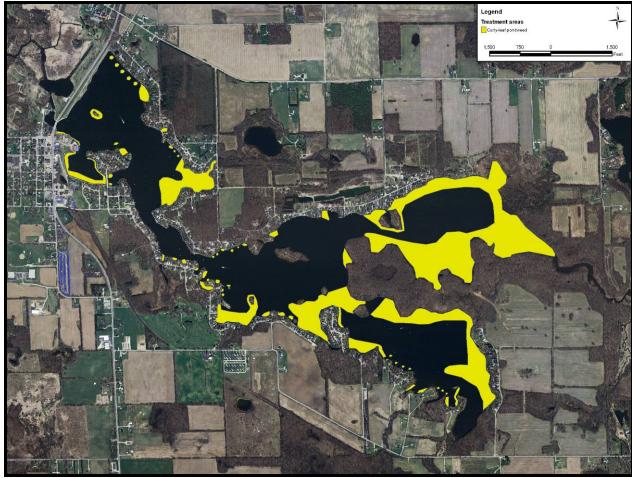
Figure 11. Curly-leaf pondweed treatment areas located on Sylvan Lake. Weed Patrol completed treatment on June 25, 2007.

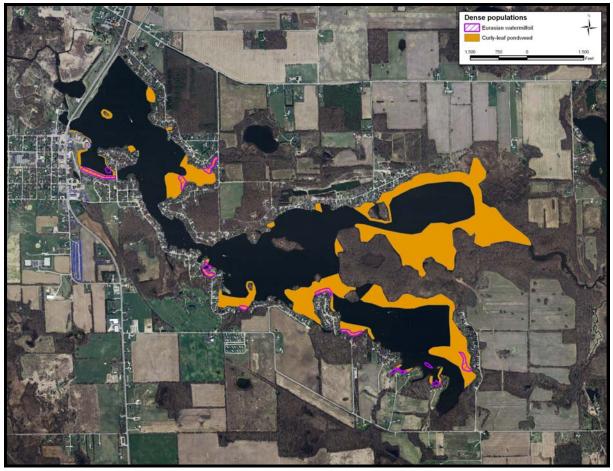
Figure 12. Dense curly-leaf pondweed and Eurasian watermilfoil locations identified within Sylvan Lake during the 2007 assessments.

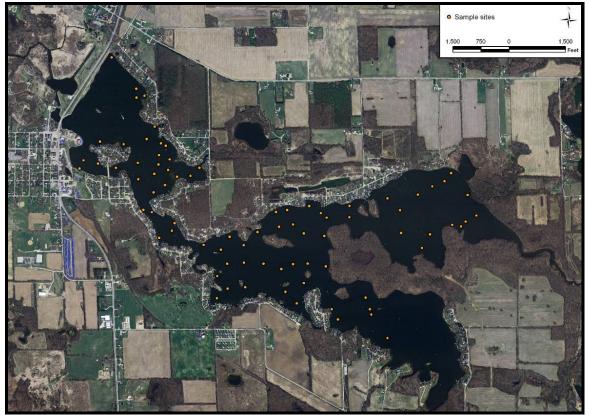
Figure 13. Sampling locations for the Sylvan Lake spring Tier II survey, June 4, 2007.

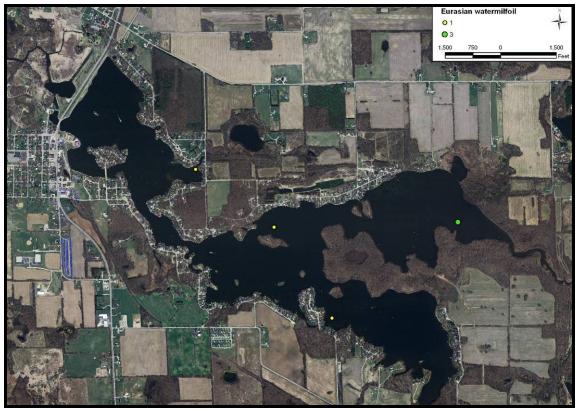
Figure 14. Eurasian watermilfoil locations and densities as surveyed June 4, 2007.

During the pre-treatment survey, coontail dominated the plant community over all depths (0-20 feet; Table 7). This species was found at the highest percentage of sites throughout the water column (47%) and also had the highest relative density. Throughout the water column, filamentous algae and curly-leaf pondweed were relatively dense and were found at 53% and 30% of sites, respectively (Table 7). Coontail, filamentous algae, and curly-leaf pondweed dominated Sylvan Lake in the 0-5, 5-10, and 10-15 foot strata (Appendix C; spring). Coontail maintained the highest frequencies for the top three strata and was equally frequent with curly-leaf pondweed and common elodea in the deepest stratum (15-20 feet). Frequencies of coontail decreased with increasing depth with coontail occurring at 75%, 44%, 41%, and 10% in the 0-5, 5-10, 10-15, and 15-20 foot strata. Dominance also decreased from a high of 35 in the 0-5 foot stratum to 13.3 at 5-10 feet, 10 at the 10-15 foot stratum, and 2 in the 15-20 foot stratum. Curly-leaf pondweed frequencies and densities followed similar patterns; however, the highest frequency and dominance occurred in the 5-10 foot stratum measuring 41% and 8.2, respectively. Frequency and dominance of curly-leaf pondweed declined in the deeper strata where curly-leaf pondweed was ultimately co-dominant and co-frequent with coontail and common elodea and were the only species identified in the 15-20 foot stratum. Eurasian watermilfoil was found in relatively low frequency and dominance throughout the water column. Figures 13 to 15 document sampling locations (Figure 13) and sites where Eurasian watermilfoil (Figure 14) and curly-leaf pondweed (Figure 15) were identified during the pretreatment survey.

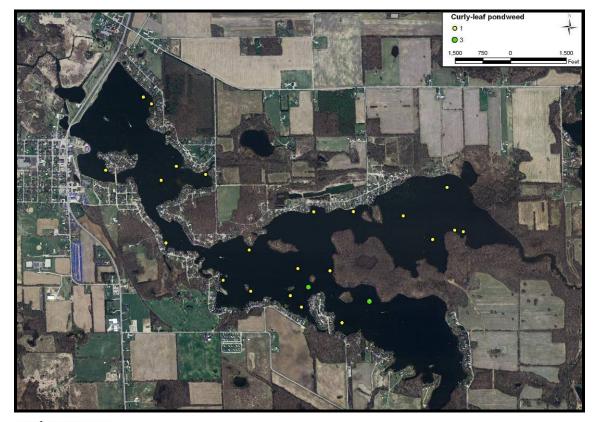
Figure 15. Curly-leaf pondweed locations and densities as surveyed June 4, 2007.

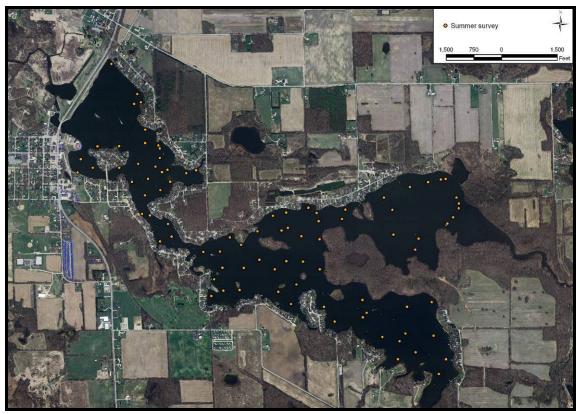
Figure 16. Sampling locations for the Sylvan Lake summer Tier II survey, July 26, 2007.

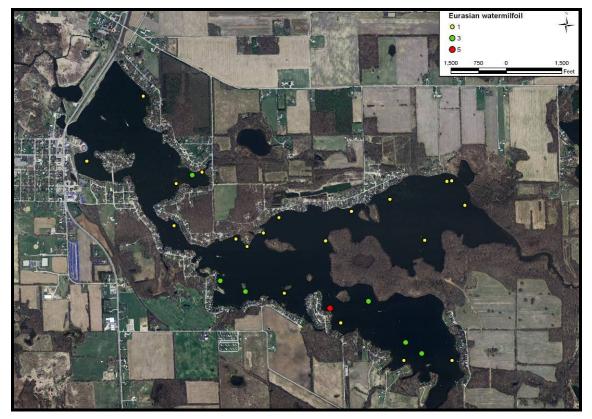
Figure 17. Eurasian watermilfoil locations and densities as surveyed July 26, 2007.

Following treatment, coontail and filamentous algae were still the most abundant species in Sylvan Lake (Table 8). Coontail was present at 56% of the sample sites and had the greatest relative and mean densities throughout the water column and in each of the three strata (0-5 feet, 5-10 feet and 10-15 feet). Throughout the water column, filamentous algae, Eurasian watermilfoil, and chara were relatively dense and were found at 31%, 30%, and 28% of sites, respectively (Appendix C; summer). Coontail dominated the shallowest strata (0-5 feet) and was identified at 84% of sites in this stratum. Coontail also possessed the highest dominance (47.2) and was nearly twice as dominant as any other species in this stratum. Chara, southern naiad, filamentous algae, Eurasian watermilfoil, and grassy pondweed were also prevalent in the 0-5 foot stratum and were present at 52%, 48%, 48%, 44%, and 28% of sites, respectively. The frequency and dominance of all species decreased with depth. Filamentous algae and coontail were the only species identified in the deepest stratum (10-15 feet). Eurasian watermilfoil was found at more sites during the post-treatment survey (30% compared to 5% during pre-treatment) and had a higher relative and mean density than that present during the pre-treatment survey. Conversely, curly-leaf pondweed was identified at only 11% of sites during the post treatment survey compared to 30% of sites during the pre-treatment survey. Figures 16 to 18 detail plant sampling locations (Figure 16) and the locations where Eurasian watermilfoil (Figure 17) and curly-leaf pondweed (Figure 18) were identified during the post-treatment surveys.

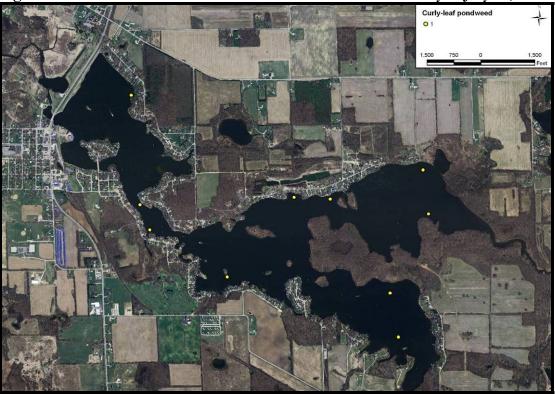
Figure 18. Curly-leaf pondweed locations and densities as surveyed July 26, 2007.

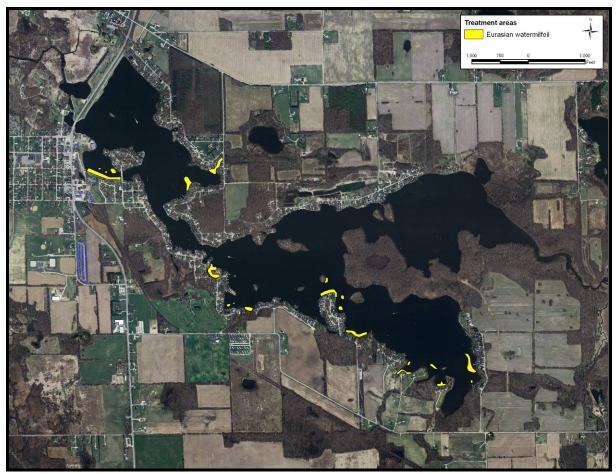
Figure 22. Eurasian watermilfoil population control recommendations for 2008.

Eurasian watermilfoil is present in relatively high density in relatively contained locations within Sylvan Lake. In order to prevent the continued spread of Eurasian watermilfoil to other locations within the lake, a control program should be enacted. Eurasian watermilfoil reproduces through fragmentation and can rapidly spread to other areas of the lake and can reach nuisance levels. This species can displace native vegetation and has a tendency to form dense canopies that shade out native vegetation. In order to control Eurasian watermilfoil within Sylvan Lake, the use of 2,4-D (Navigate) or Renovate for spot treatment of populations is recommended. Up to 19 acres of Eurasian watermilfoil are recommended for treatment (Figure 22). The cost of this treatment is approximately \$10,000 if 2,4-D is used for treatment within Sylvan Lake. Additional annual follow-up treatments would likely be necessary to control Eurasian watermilfoil populations within Sylvan Lake.

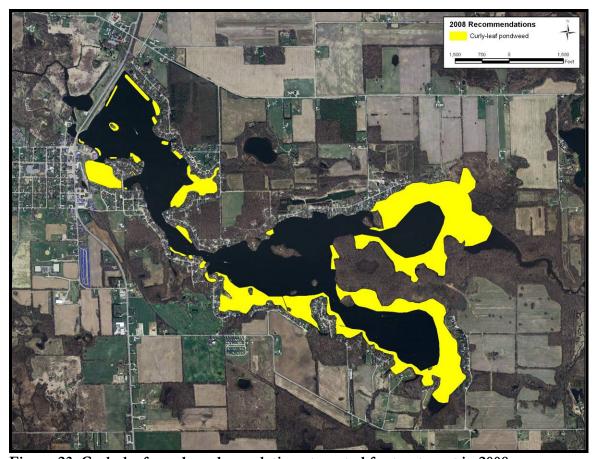
Figure 23. Curly-leaf pondweed populations targeted for treatment in 2008.

and is especially dense in the headwater of Pit Lake and Cain Lake basins. In total, curly-leaf pondweed covers approximately 200 acres of Sylvan Lake (Figure 23). Historically, curly-leaf pondweed covered nearly 300 acres of Sylvan Lake. As such, these areas likely contain resident turions which are present within the sediment covering this portion of the lake. Aquathol K is recommended for treatment of these areas and should continue to occur over several consecutive summers to reduce the growth and production of turions, which can last for multiple seasons after treatment. Given the desire to ensure long-term control of curly-leaf pondweed and to reduce the production of turions, curly-leaf pondweed treatment should occur at a rate of 1 mg/L (0.6 gallons/acre in shallow water to 3.8 gallons/acre in deeper water) before water temperatures reach 50 °F. Estimates completed by Weed Patrol suggest that treatment of curly-leaf pondweed should continue to decline over time with an estimated treatment of 300 acres in 2008.

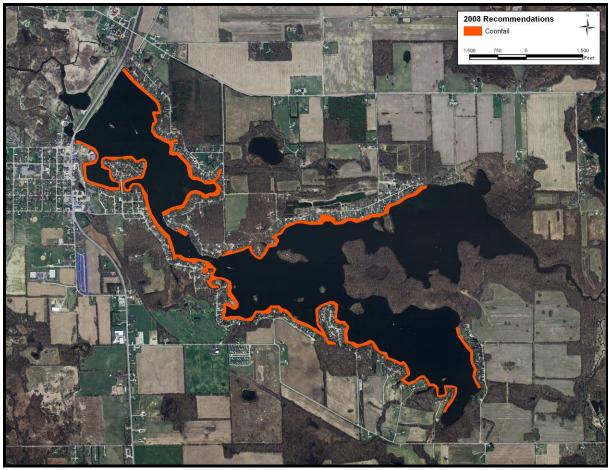
Figure 24. Priority areas of coontail treatment in 2008.

Coontail growth along the shallow shelf present in the lower basin of Sylvan Lake has reached nuisance levels. Areas where control should occur is limited to those locations where coontail limits individual's access from their pier to the lake. Additionally, treatment should not occur along natural, undeveloped shorelines or in areas where boat access is not a high priority. The areas prioritized for treatment are displayed in Figure 24.
